Hamakua Police Station & CCC CRIFU

## LARGE CAPACITY CESSPOOL (LESS THAN 1000 GPD) BACKFILLING FINAL COMPLETION REPORT Wastewater Branch, Dept. of Health, State of Hawai'i

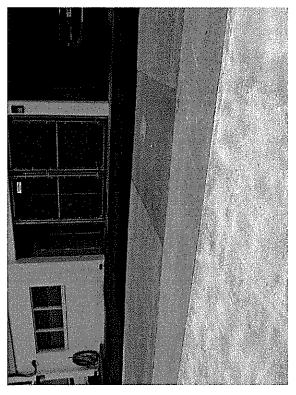
Photo 2-4/3/2007 - Post (Finish) Condition 20 feet away from cesspool location.

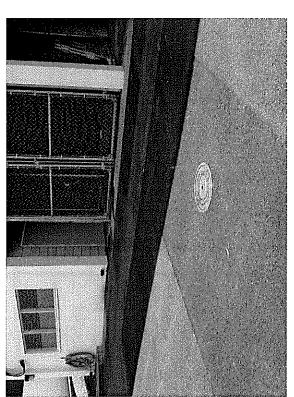
Photo 1-4/3/2007 - Post (Finish) Condition 8 feet away from cesspool location.
